## Rapid repair of severely earthquake-damaged bridge piers with flexural-shear failure mode

**Abstract:** An experimental study was conducted to investigate the feasibility of a proposed rapid repair technique for severely earthquake-damaged bridge piers with flexural-shear failure mode. Six circular pier specimens were first tested to severe damage in flexural-shear mode and repaired using early-strength concrete with high-fluidity and carbon fiber reinforced polymers (CFRP). After about four days, the repaired specimens were tested to failure again. The seismic behavior of the repaired specimens was evaluated and compared to the original specimens. Test results indicate that the proposed repair technique is highly effective. Both shear strength and lateral displacement of the repaired piers increased when compared to the original specimens, and the failure mechanism of the piers shifted from flexural-shear failure to ductile flexural failure. Finally, a simple design model based on the Seible formulation for post-earthquake repair design was compared to the experimental results. It is concluded that the design equation for bridge pier strengthening before an earthquake could be

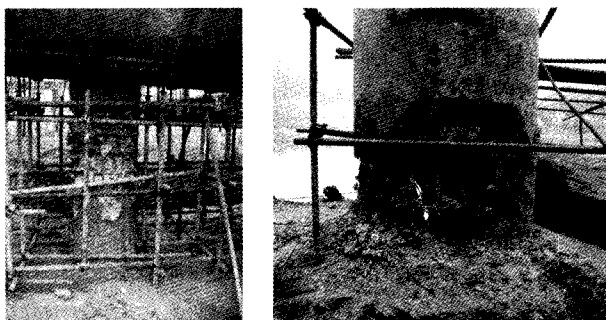
severe damage as shown in Fig. 1 and required either repair or demolition for reconstruction. If damaged bridge piers could be repaired and rehabilitated rapidly, it would be both more economical than demolishing and reconstructing the bridges, and also extremely important for rescue efforts after an earthquake.

**Fig. 1** Representative flexural-shear damage to bridge piers observed after the Wenchuan earthquake

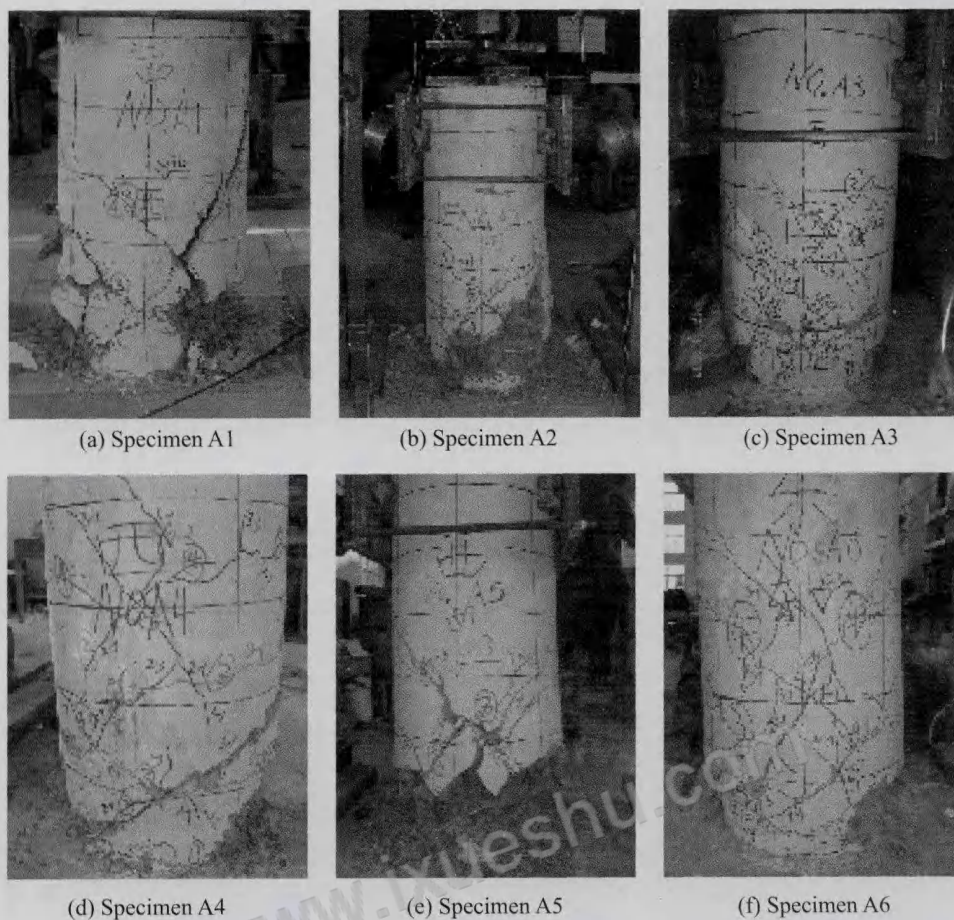
and in some cases, rupturing of spiral bars. Note that no longitudinal bar rupture was observed in any of the specimens. The damage details of the original pier specimens are summarized in Table 2 and depicted in Fig. 6. The damaged pier specimens were pushed back to their original position (i.e., zero lateral displacement) before the repair operation began.

Specimen	Concrete damage		Reinforcing bar damage	
	Spalled height (mm)	Core crush depth (mm)	No. of buckled longitudinal bars	Spiral bar fractured or not
A1	200	100	5	No
A2	150	Full depth	6	Yes
A3	100	Full depth	6	No
A4	200	Full depth	4	No
A5	210	Full depth	6	Yes
A6	105	100	8	Yes

Fig. 6 Final failure patterns of the original pier specimens

The repair procedures were similar for all the damaged pier specimens and can be summarized as follows: (1) the damaged concrete in and around the damage region was removed, and the pier surface of the damage region was cleaned using a high-pressure air gun; (2) the buckled longitudinal bars were straightened by pounding them with a rubber hammer, and then the fractured spiral bars in specimens A2, A5 and A6 were welded together using new similar reinforcing bars; (3) early-strength concrete with a measured compression strength at 3 days of 31.5 MPa within the damage region was cast, and the surface of the pier specimens was finished to their original shape and dimension. Note that concrete with high fluidity was used in the current study. The proportion for the mixtures of the early-strength concrete with high fluidity

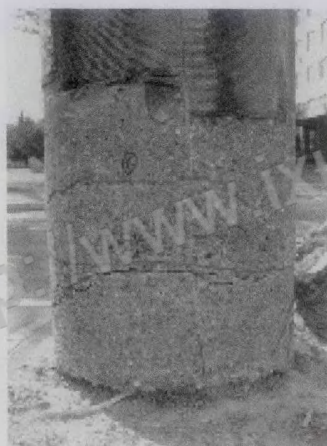
The CFRP sheets of the specimens were removed after the test to investigate the damage to the concrete inside. Flexural cracking and slight spalling of the concrete cover were observed within the plastic hinge region of the specimens. However, no significant diagonal shear cracks were found. Thus, it is apparent that the failure mode of the repaired specimens should be identified as flexural failure. Figure 7 shows the failure patterns of the repaired specimens at the end of the testing.

(a) Specimen RA1 (CFRP removed)

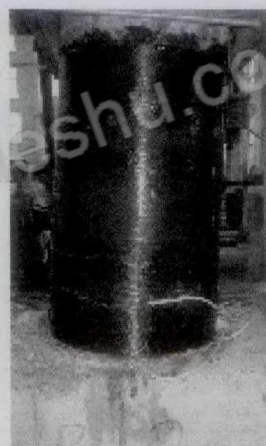
(b) Specimen RA2

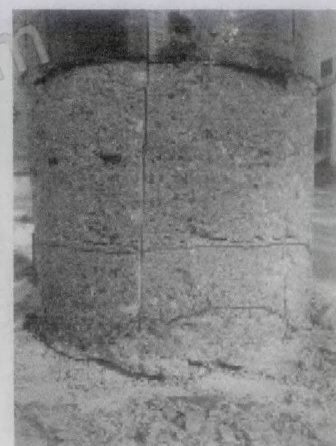
(c) Specimen RA3 (CFRP removed)

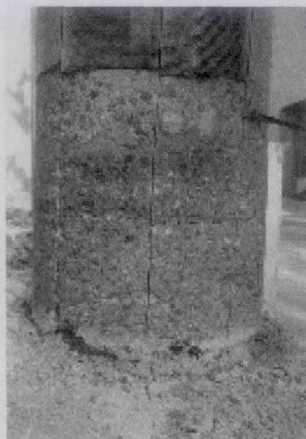
(d) Specimen RA4 (CFRP removed)

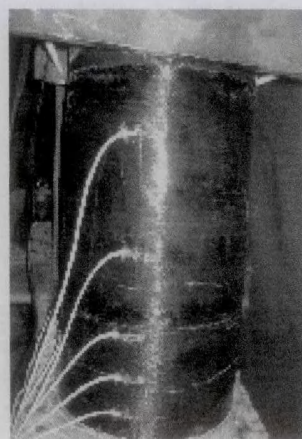
(e) Specimen RA5

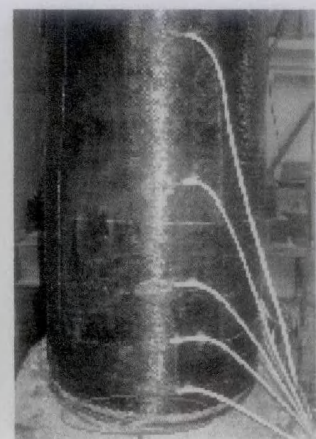
(f) Specimen RA6

concrete spalling occurred at the base of the pier and the load carrying capacity of the specimen decreased. Fiber ruptured and a snapping noise occurred in specimen RA6 during the last loading cycle. However, neither delamination nor rupture damage of the CFRP sheets was observed in any of the other repaired specimens until the end of the testing. Table 4 summarizes the measured top displacements of the specimens at different damage states. Note that the repair technique delayed the concrete cracking and spalling of the specimens.

Rupturing of the CFRP
